**Executive Summary:**

**Site/Project Location:** Spread 7-8 in Morton County

**Date of Inspection:** 27 October 2016

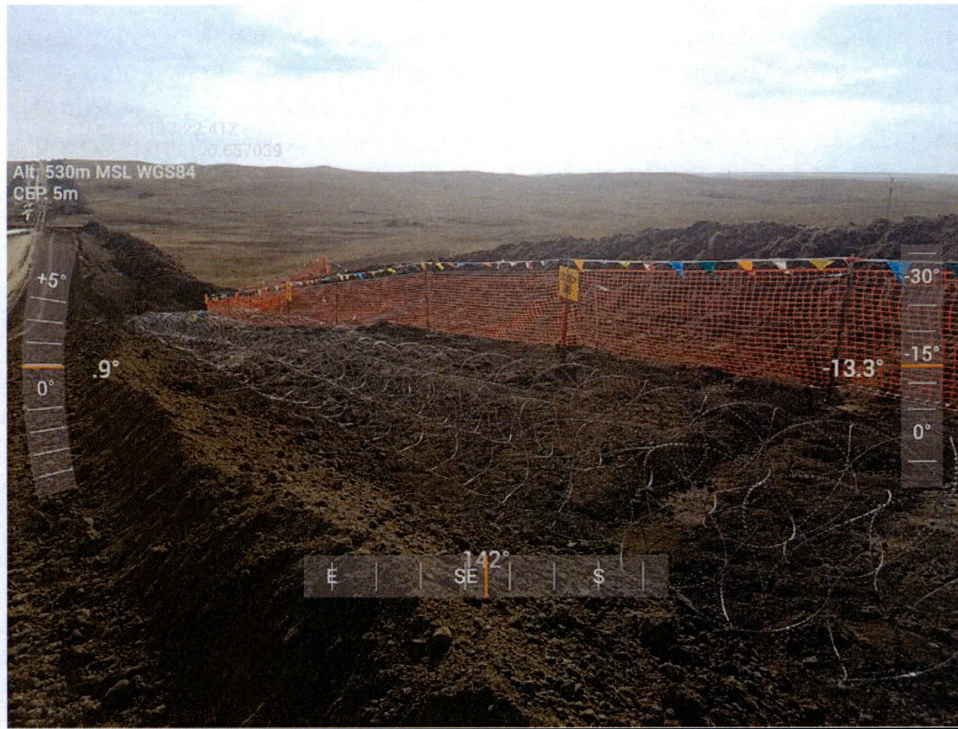
Inspection of the main area of construction, MP 161 through MP 164, was cut short due to protest activity nearby. The Keitu Inspector was escorted by Chris Grant. Shortly after beginning, Chris Grant received a phone call stating that he had to leave the area due to safety concerns. Exclusion areas were built around areas that Tribal members had deemed culturally significant during a previous visit. See photo #1.

**Report Photo #1 Exclusion Zone**

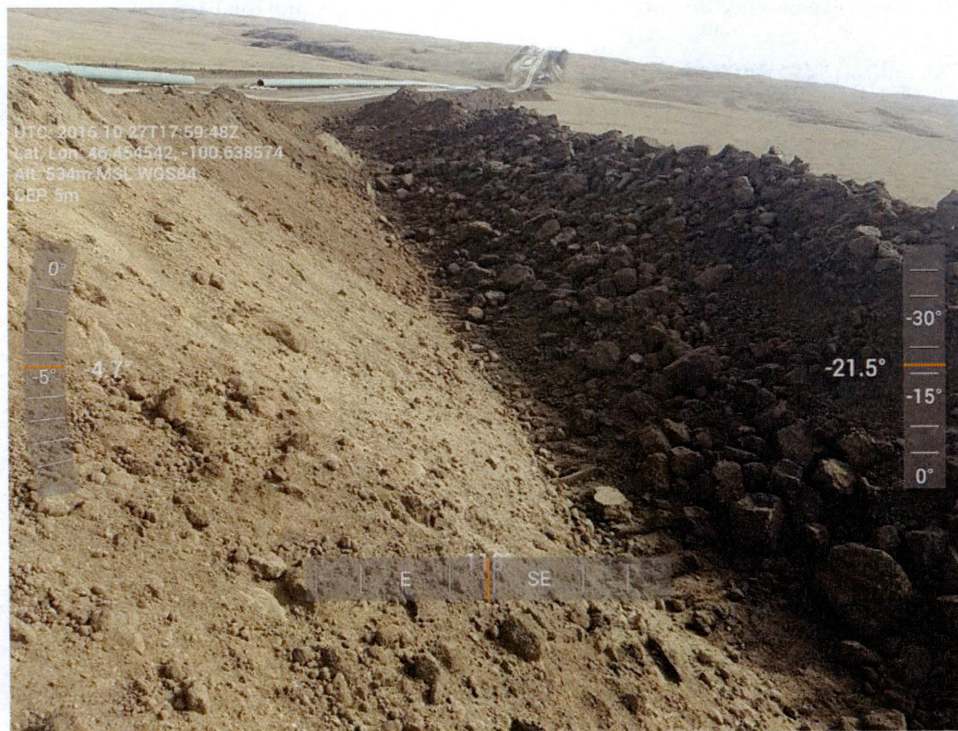
Topsoil and subsoil segregation appeared adequate. A majority of the topsoil and subsoil piles from stripping and grading showed clear separation. There were small areas where the subsoil and topsoil piles were nearly touching, but it was clear that no mixing had occurred. Storm water BMPs had not been installed east of MP 161. Chris Grant, Lead Environmental Inspector for Dakota Access Partners, stated that environmental crews had not yet been able to install BMPs east of MP 161 because of restricted access due to protestors.

**Report Photo #2 Subsoil and Topsoil Segregation**

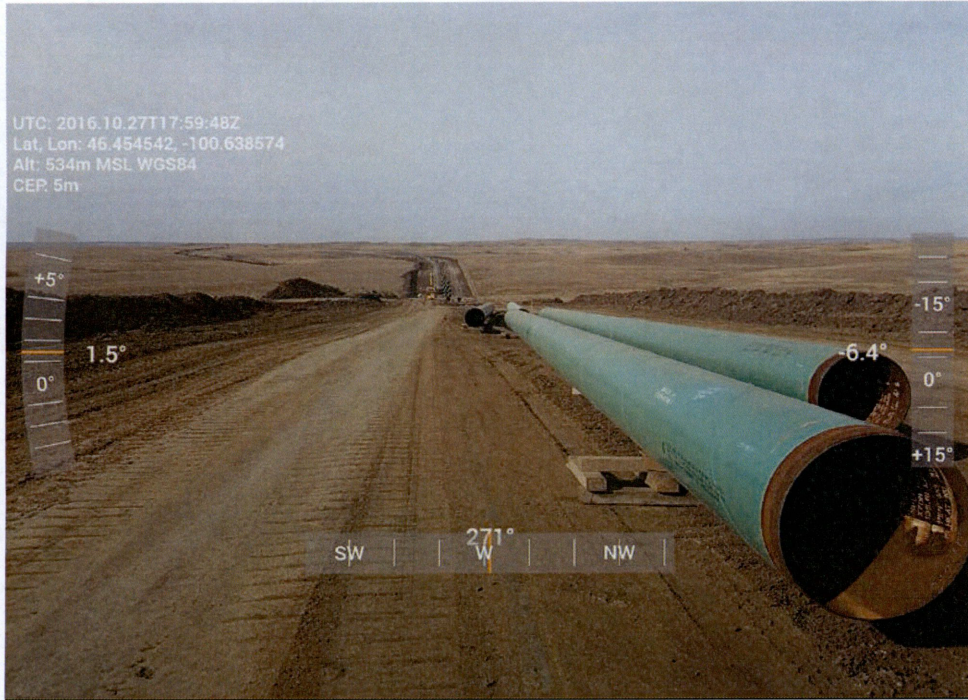
**Report Photo #3 Pipe String Waiting on Welding Crew**

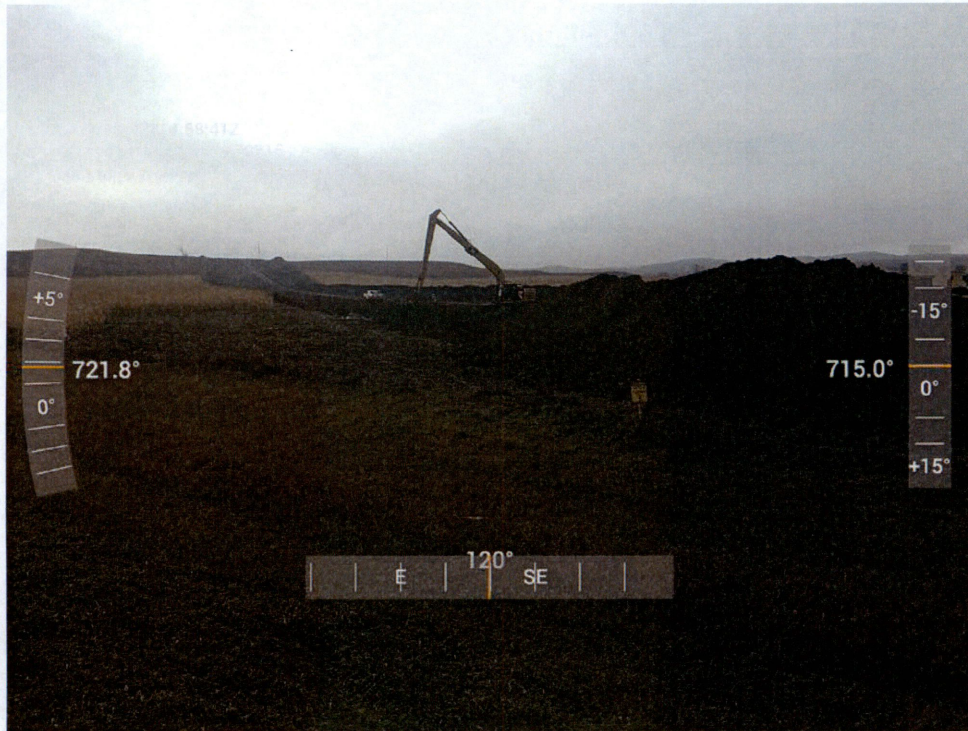
**Report Photo #4 Backfilling**

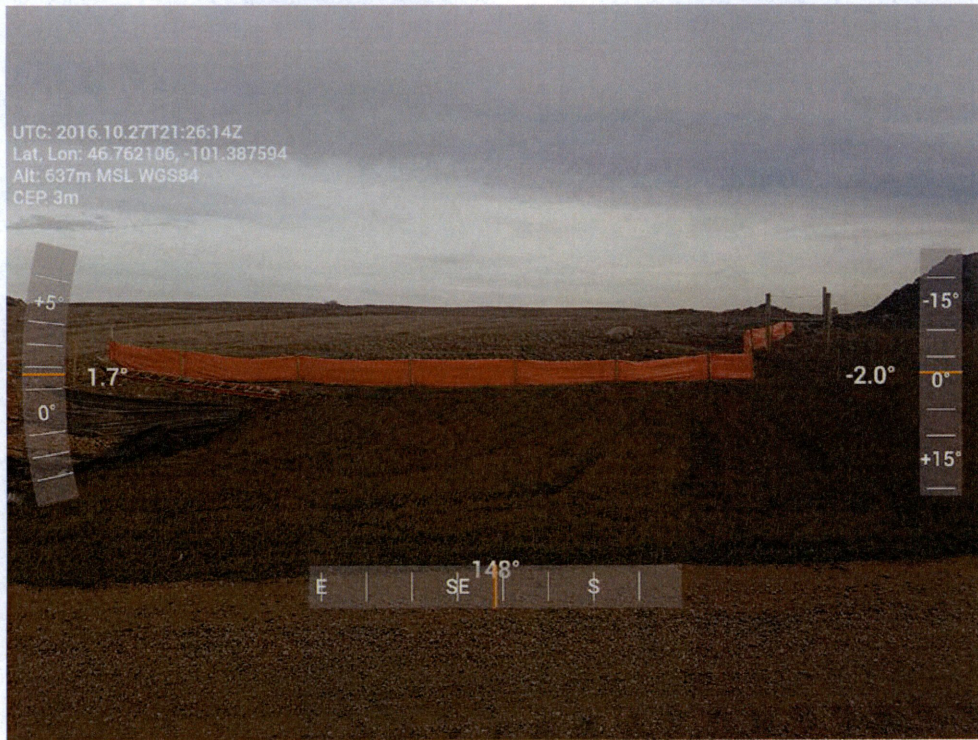
Open trench areas observed appeared to be at specified depth or deeper. Silt fence was implemented to prevent any sediment from leaving the ROW.

**Report Photo #5 Silt Fence Protecting Road Ditch**

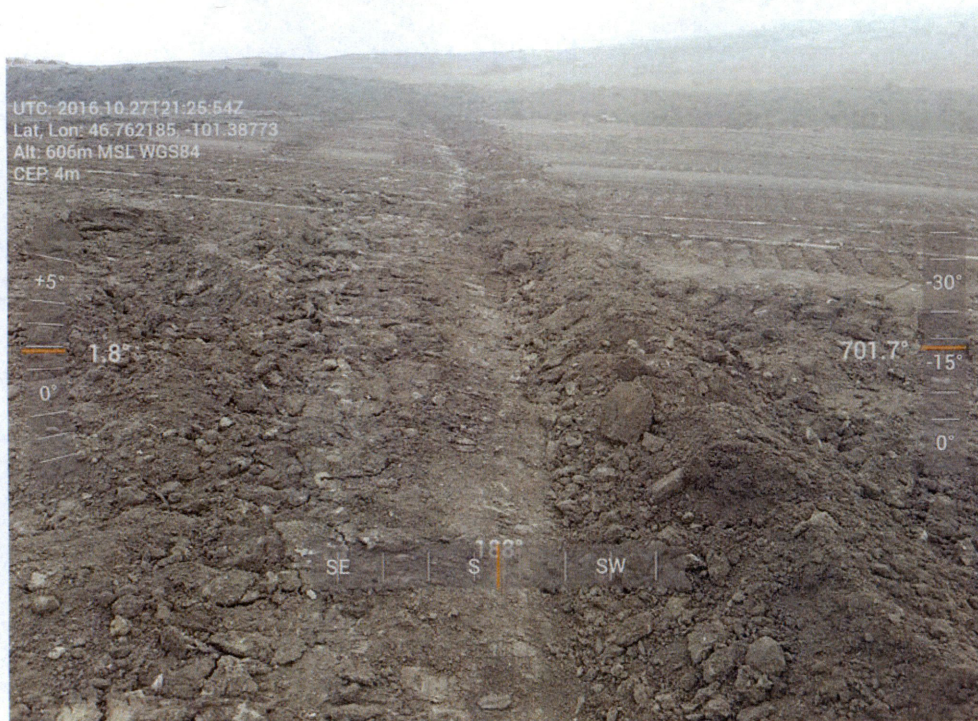
**Report Photo #6 Temporary Water Bar in Subsoil**

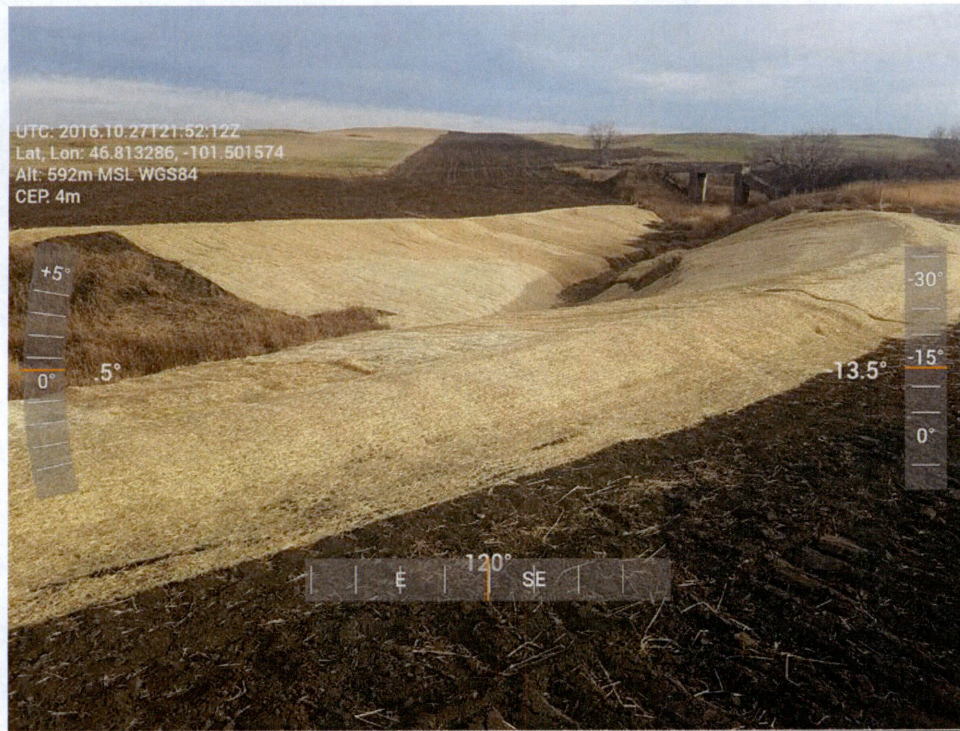
**Report Photo #7 Water Bars and Erosion Matting Around Stream**

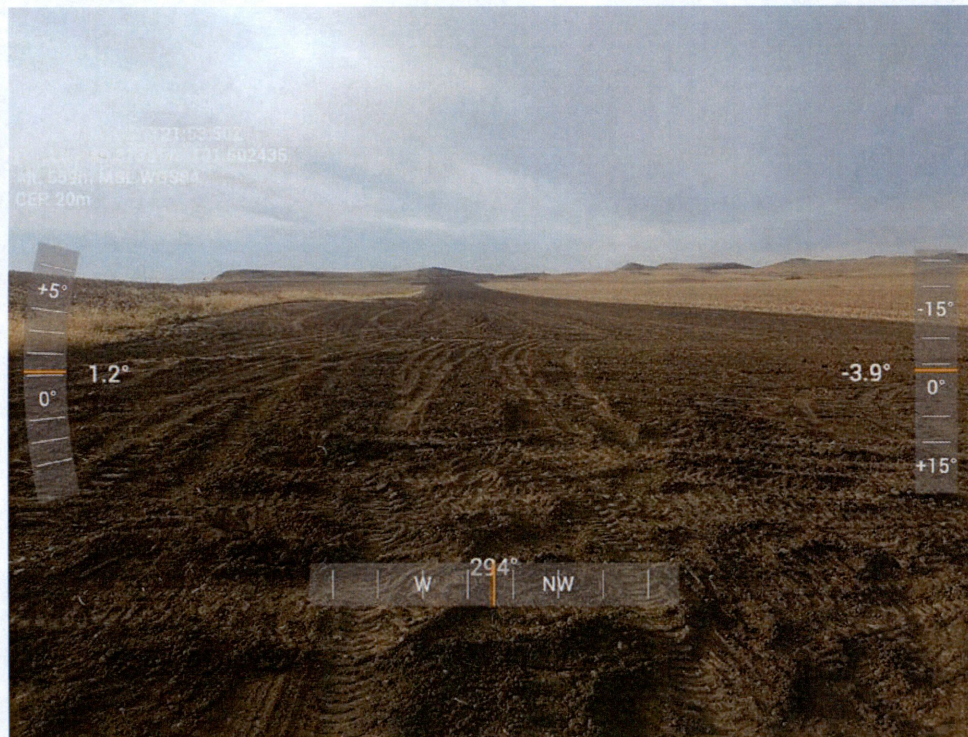
**Report Photo #8 Replaced Topsoil**
